## Inspector's Daily Report

IDR Sheet	1	of	1	Sheets	Final Record Book	Page
Contract		Day			Date	
C-7852		Tuesday			August 2, 2011

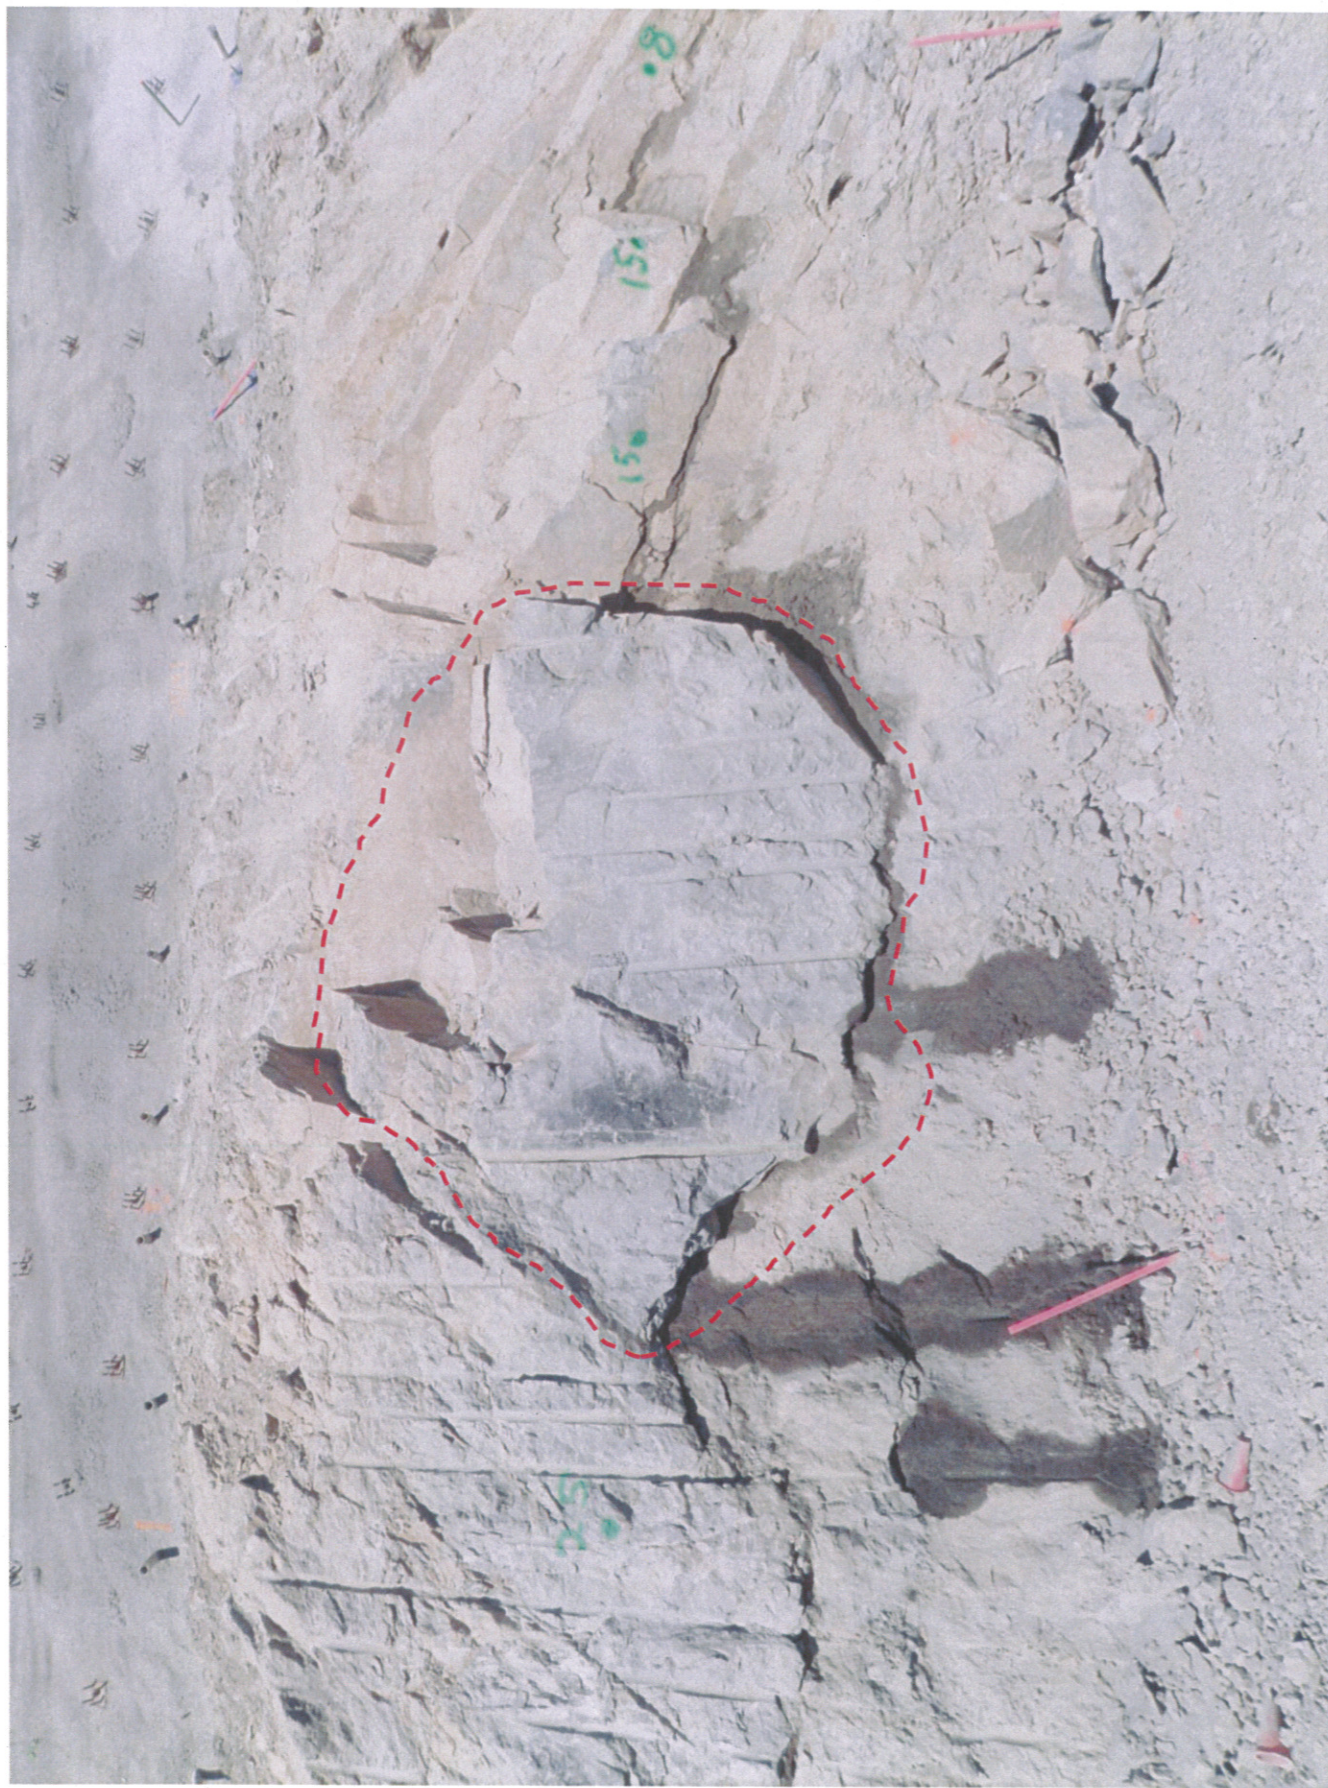
Figure 1. A photograph showing the detached rock block around station 1348+00. Note the tension cracks on all sides and the water emitting from the bottom.

I walked to the east and performed some additional structure mapping as requested from the Geotechnical Division from approximate station 1342+50 to 1344+50. While I was mapping, the contractor asked if they could mechanically scale the detached rock block that Eric Smith referred to in his IDR from 7/29/11 around station 1348+00. The detached rock block has tension cracks on all sides with water emitting from the bottom of the block (Figure 1). I indicated that it was appropriate to remove the detached block but we would want to inspect the face following the removal of the rock block and lay out the intended dowels that Eric had in his IDR. Around 5:30 pm the contractor mechanically scaled the rock block (Figure 2). The face behind the block has adversely oriented structure as shown in Eric Smith's IDR and we decided that we would mark the dowel locations first thing in the morning.

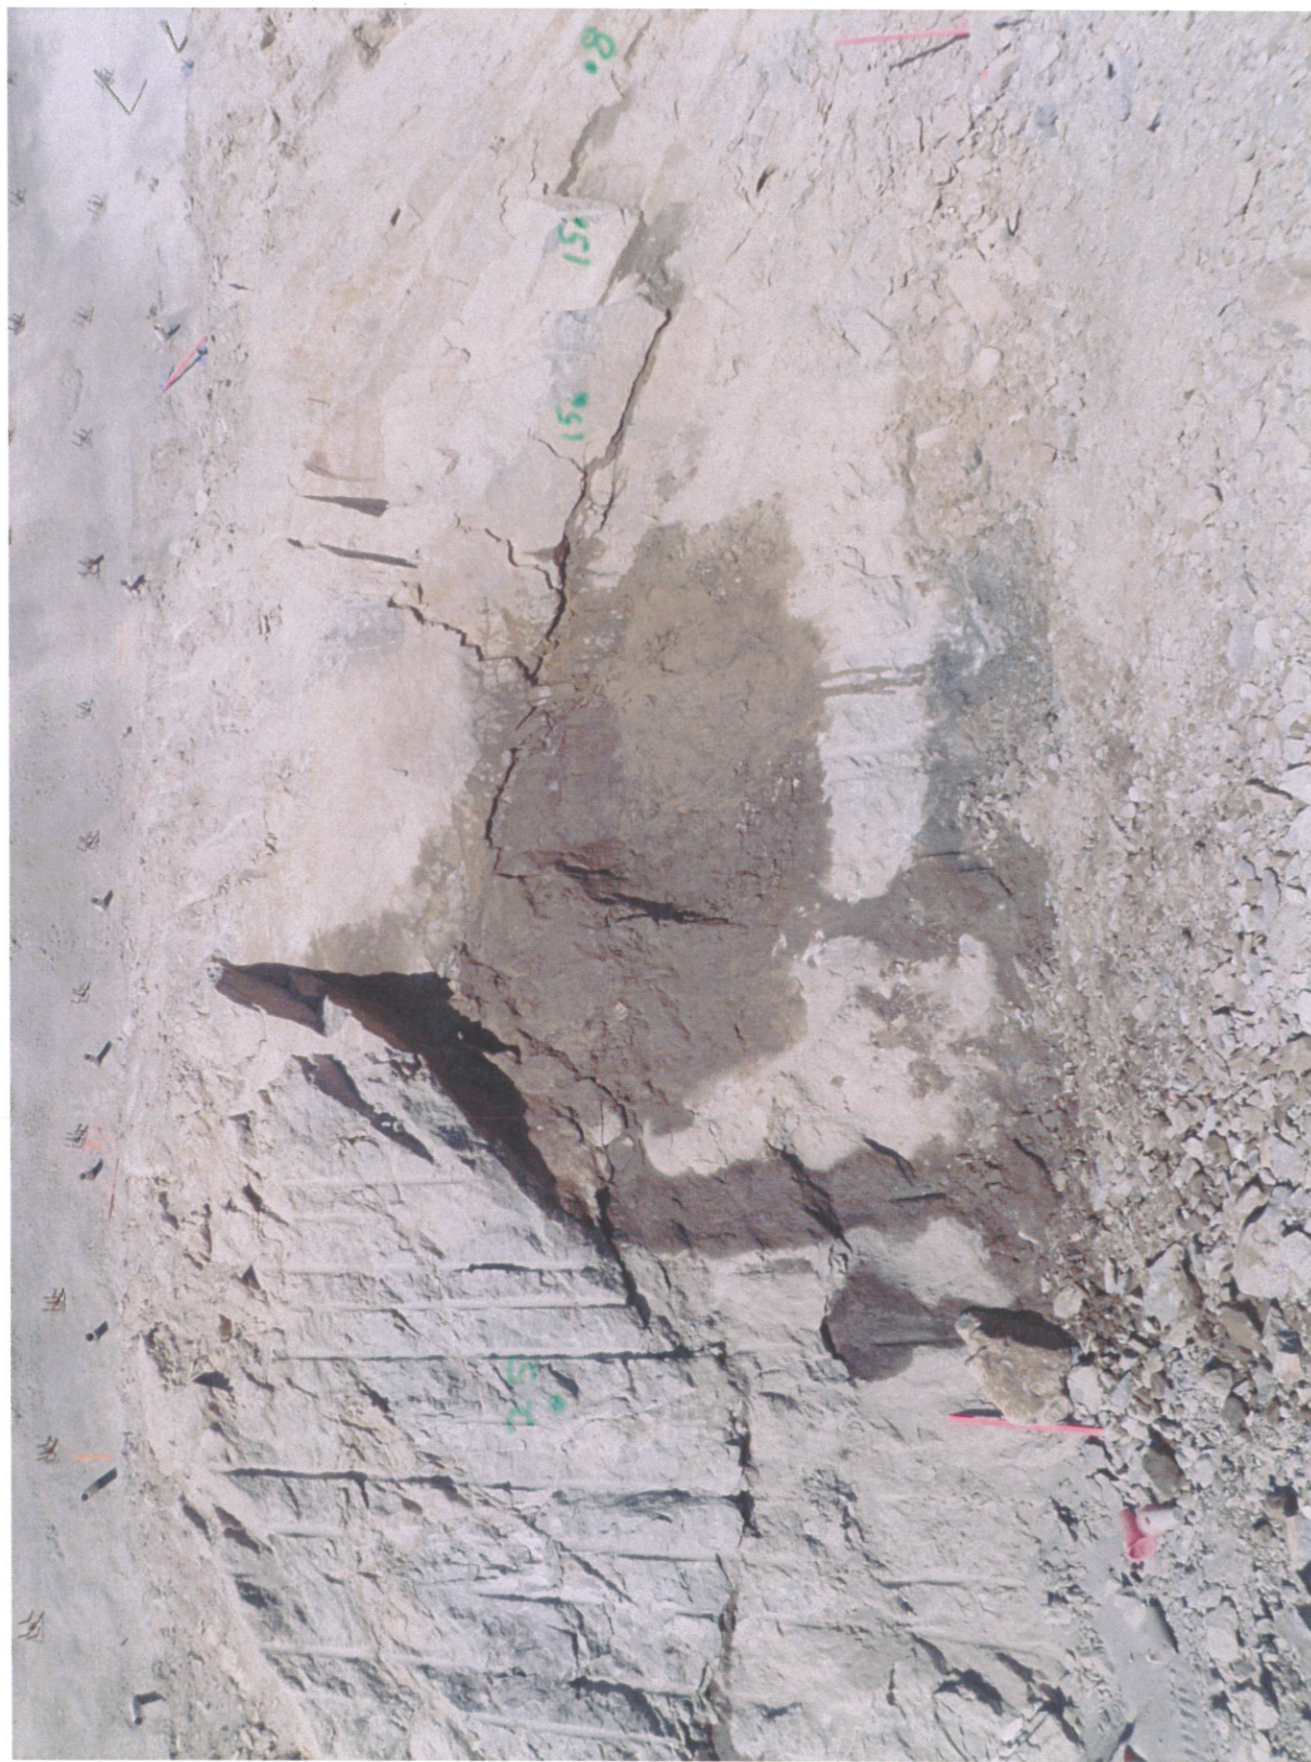
Figure 2. A photograph showing the rock face following the mechanical scaling around station 1348+00.
